[Docket No. 2001-SW-50-AD; Amendment 39-12838; AD 2002-15-08]

Airworthiness Directives; Eurocopter France Model EC120B, EC 155B, SA330F, SA330G, SA330J, AS332C, AS332L, AS332L1, AS332L2, AS350B, AS350BA, AS350B1, AS350B2, AS350B3, AS350D, AS355E, AS355F, AS355F1, AS355F2, AS355N, AS365N2, AS 365 N3, SA-365N, and SA-365N1 Helicopters

2002-15-08 Eurocopter France: Amendment 39-12838. Docket No. 2001-SW-50-AD.

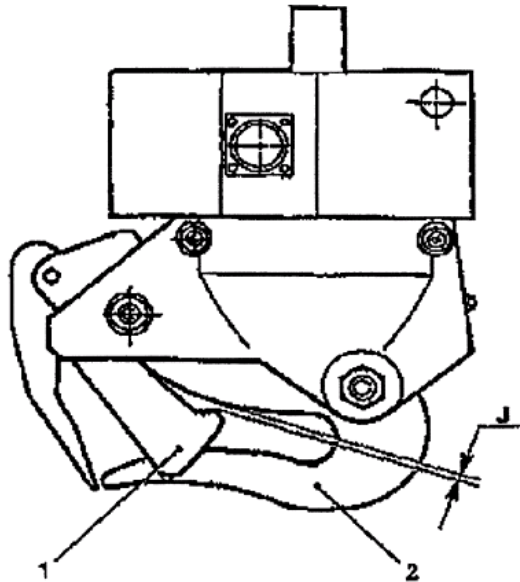
The Direction Generale De L'Aviation Civile (DGAC), the airworthiness authority for France, notified the FAA that an unsafe condition may exist on various ECF model helicopters. The DGAC advises of the discovery of an anomaly on the locking catch of certain cargo hooks that could jam the ring on the cargo hook and jeopardize the release of an underslung load.

Clearance "J" must be less than 14 mm (0.55 inches)

(a) With the cargo hook in the no-load position, measure the clearance "J" in accordance with Figure 1 of this AD. Remove any cargo hook if clearance "J" is equal to or greater than 14 millimeters (0.55 inches). See Figure 1:
